# **REPORT OF APOLLO 204 REVIEW BOARD**

**APPENDIX D  
PANELS 6 thru 10**

**REPORT OF PANEL 6  
HISTORICAL DATA  
APPENDIX D-6  
TO  
FINAL REPORT OF  
APOLLO 204 REVIEW BOARD .**

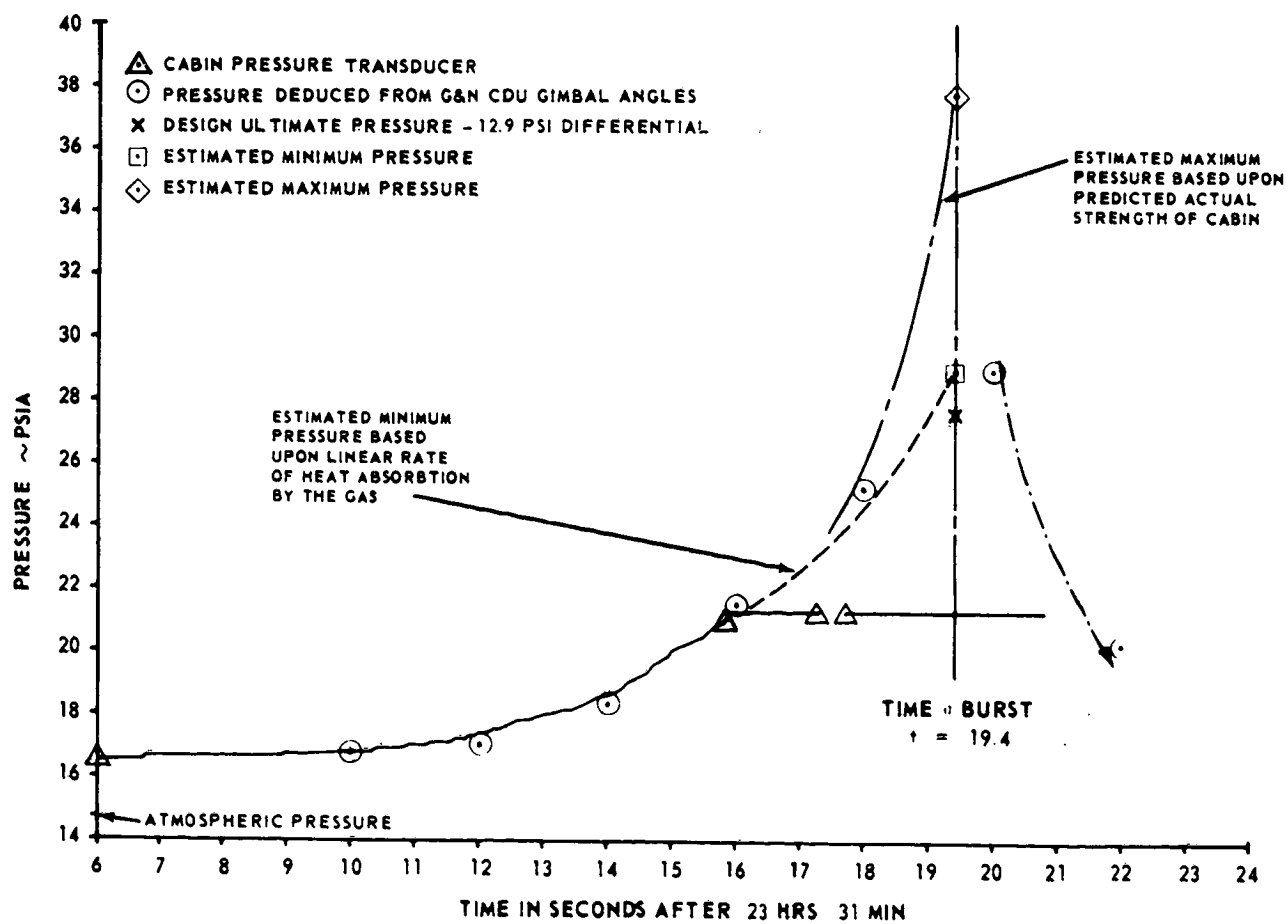
ENCLOSURE 10-2

CABIN PRESSURE

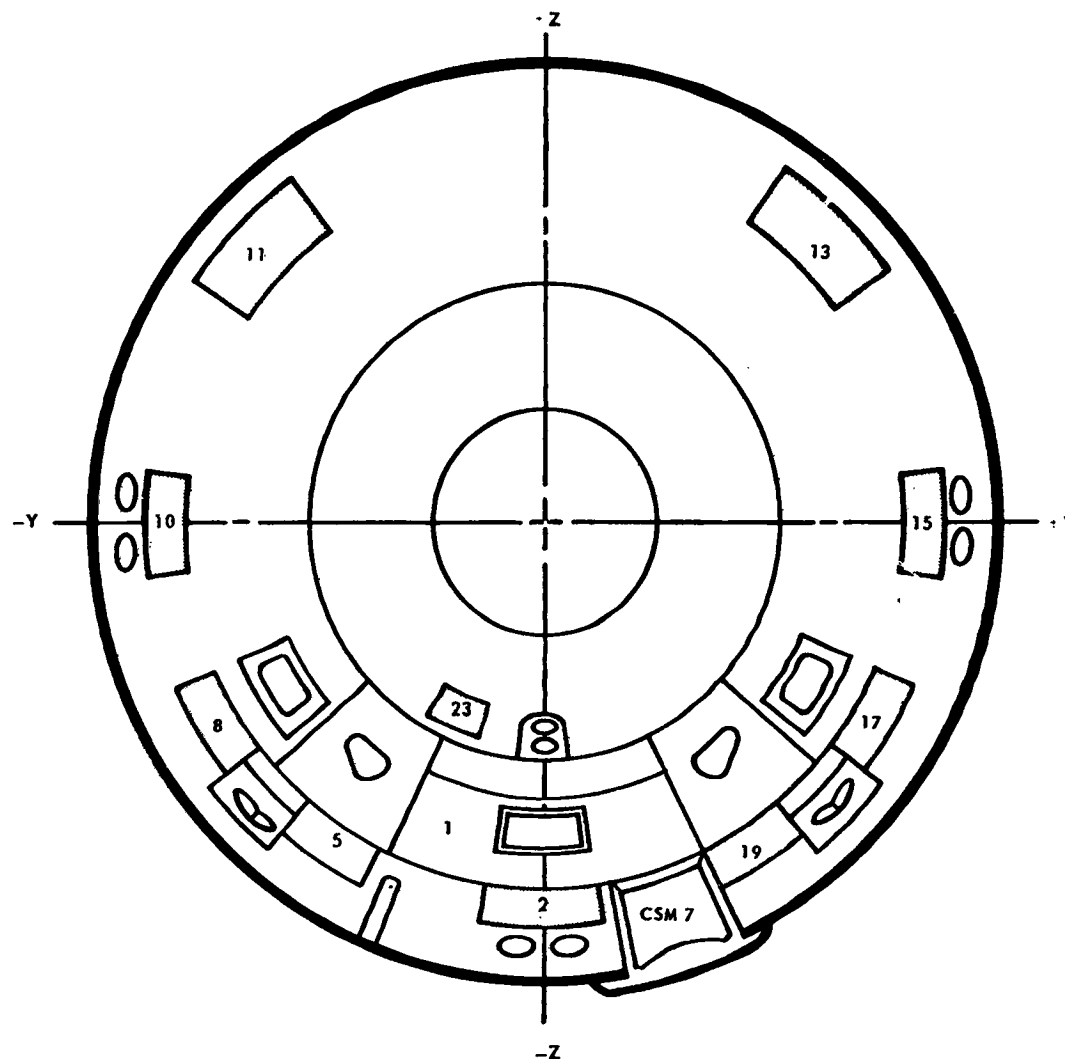
ENCLOSURE 10-3

NOTE: SHADED PANELS REPRESENT AREAS OPEN AT THE TIME OF THE ACCIDENT

HEATSHIELD ACCESS PANELS

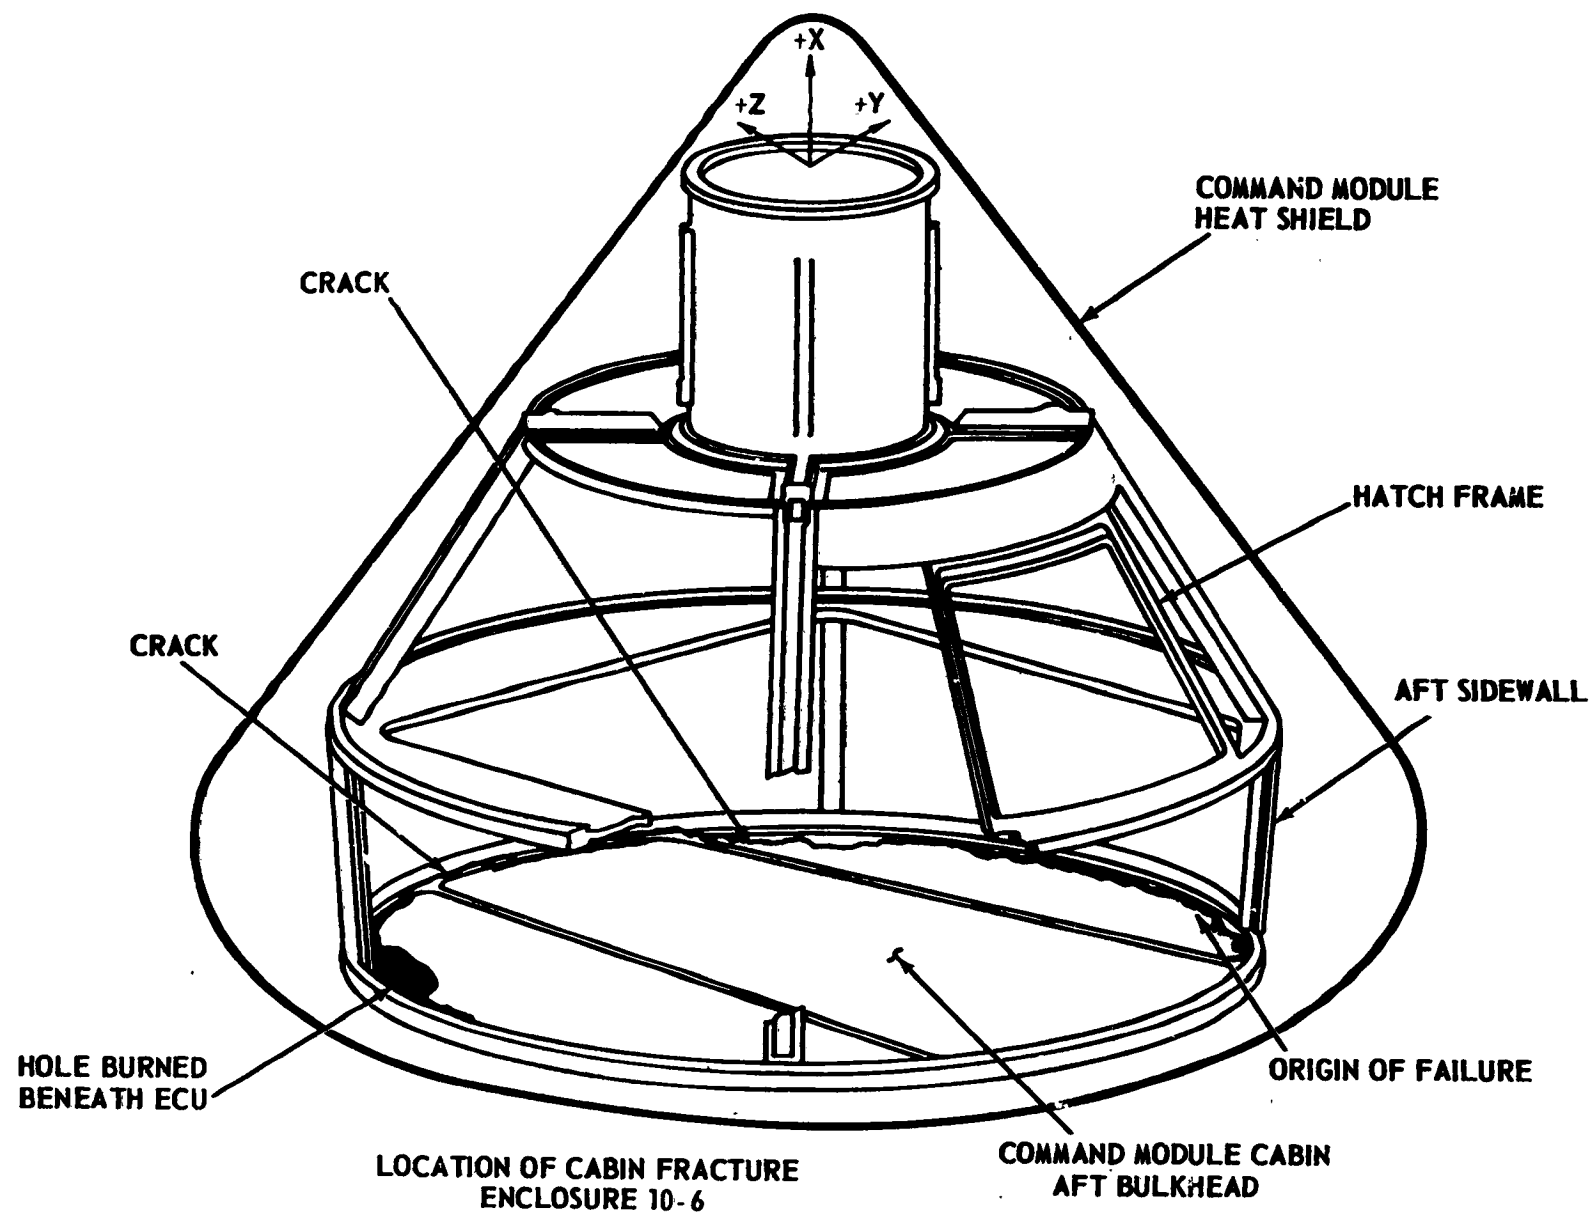
ENCLOSURE 10-7

LOCATION OF CABIN FRACTURE
